Town of Drumheller COUNCIL MEETING AGENDA

**December 2, 2013 at 4:30 PM
Council Chamber, Town Hall
224 Centre Street, Drumheller, Alberta**

Appendix – East Coulee School Museum Condition Report

EAST COULEE SCHOOL MUSEUM

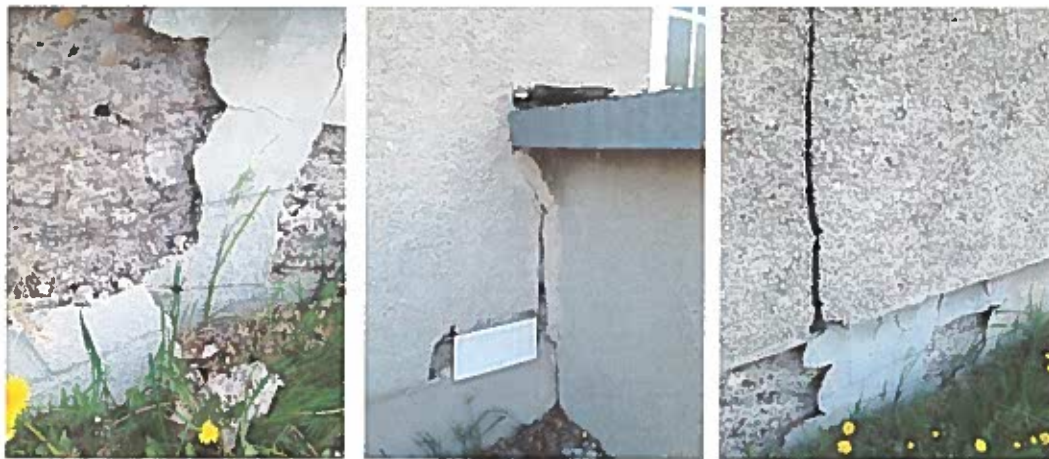
- i) Condition: The foundation wall is cracked and sinking on the north end of the west wall. It has caused the stucco to break away from the substrate. The parged surface is braking off the face of the wall. The foundation to the basement mechanical room entrance is cracked and leaning inward.

- ii) Recommendation: The cause of the structural failure could be attributed to the accumulation of roof storm water drainage along the west side of the building and inadequate positive slope away from the building. Remediation of the site drainage should be a high priority. Structural repair of the foundation walls as recommended by a structural engineer.

- iii) Estimated Cost:
 - (1) Site grading and re-seeding surface along the west side of the building: \$10,000
 - (2) Foundation repair engineering: \$6,000

- (3) Shoring, selective demolition and reconstruction of 40' of foundation wall: 20,000

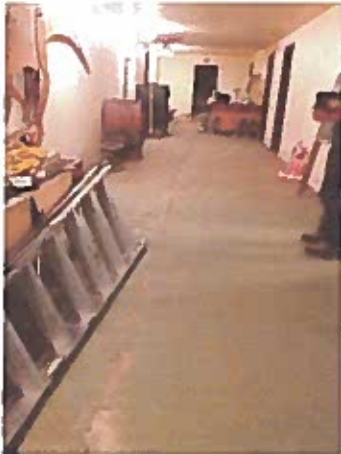
- i) Condition: The surface of the slab is deteriorated along what appears to be a joint between two separate pours. This could be a tripping hazard. On the one side, the surface is uneven compared to the other side.
- ii) Recommendation: Clean the surface, remove loose pieces, fill areas where tripping may be a hazard, and re-paint the floor.
- iii) Estimated cost of surface preparation and painting: \$9,000.

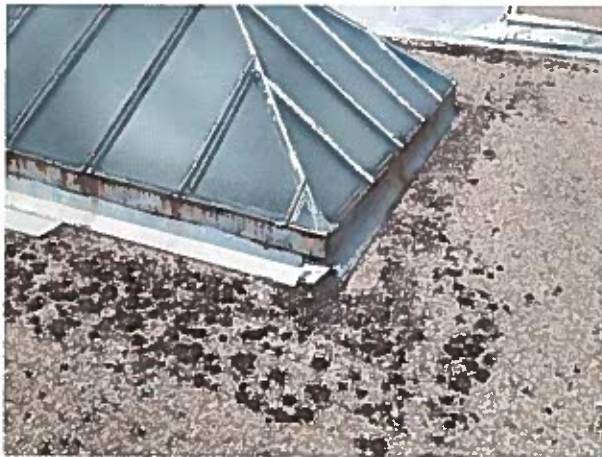
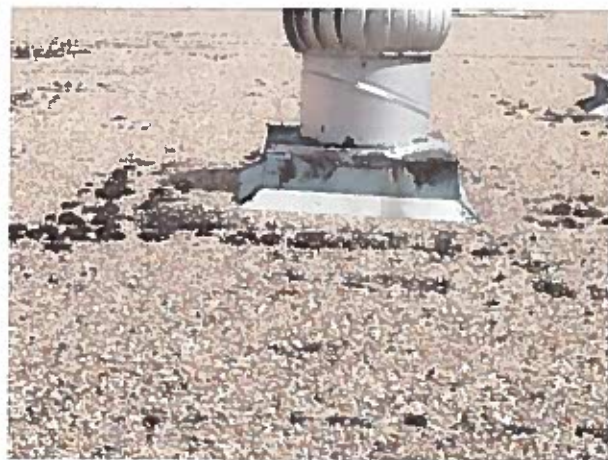
- i) Condition: The roofing is in poor condition. There is beading and soft spots. Several leaks have been patched. Flashings are rusty, the finishes have worn off on parts and the larger areas have a patchwork of flashing pieces. There is ceiling damage due to roof leaks. When the b-vent was added to serve the gas fired space heater in the basement, the roof penetration was not adequately sealed. Also, the location of this roof penetration is poor in that it is at a low spot where snow accumulates and melts from the heat off the flue, causing ponding and ice damming on the roof.

- ii) Recommendation: Replace all roofing with new built-up roofing system. Refer also to the mechanical section below. Repair the roof upon removal of added mechanical equipment venting.

- iii) Estimated Cost: \$80,000 based on replacement of 8,700sf of surface area, removal of existing, patching of damaged sections, and replacement of flashings.

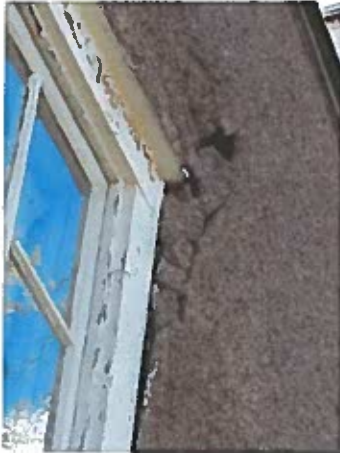
- i) Condition: There are several areas on the surface where the stucco is cracked and has holes. Along the west wall toward the north, where the foundation has failed, the stucco
- ii) Recommendation: Repair stucco finish in damaged areas following structural remediation. Match the existing stone surface treatment.
- iii) Estimated Cost: \$5,000 based on an area of about 20 m² matching and patching existing.

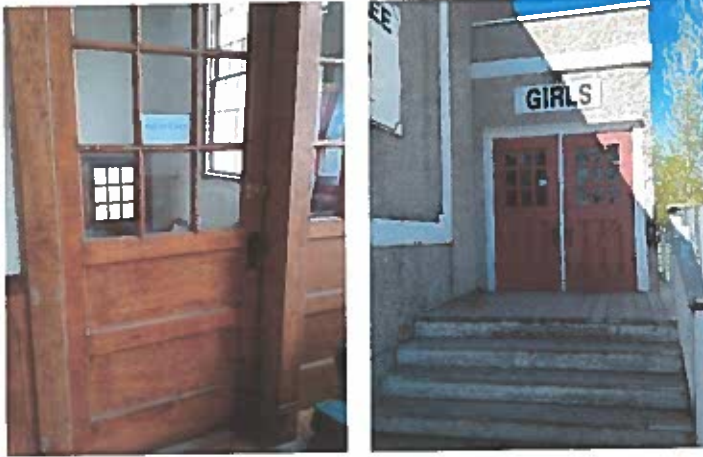
- iii) Condition: The wood is exhibiting normal wear and tear for a building of this age. No significant warping was noticed. Some hardware functions poorly.
- i) Recommendation: Sand and re-finish existing doors and frames. Replace selective hardware with a style to match existing.
- ii) Estimated Cost: \$1,000 for refinishing of 4 exterior doors, both sides.

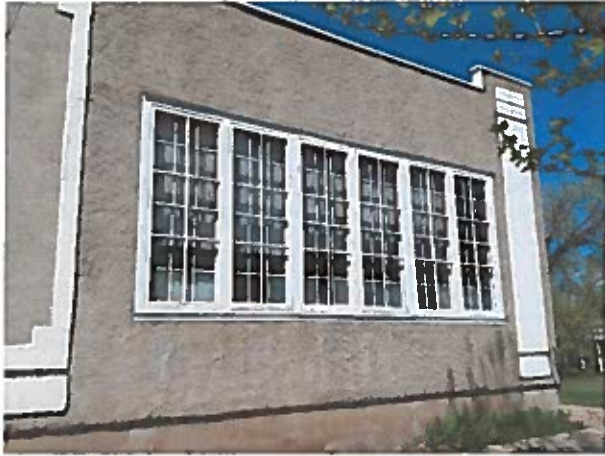
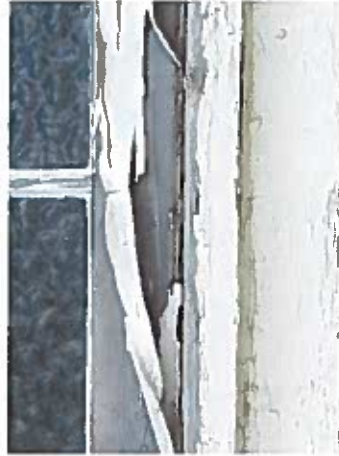
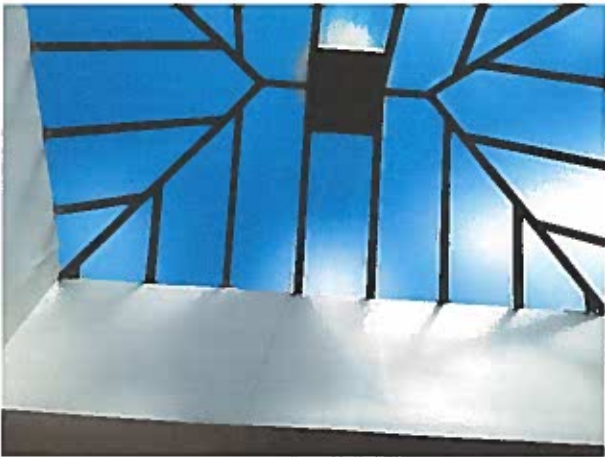
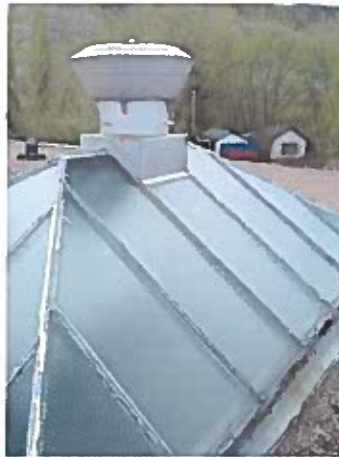
- i) Condition: The painted finish is peeling. Some wood is weathered and damaged. Some storm sashes are missing. The skylight appears to be leaking at the perimeter flashing locations but the finish damage could be from condensation.
- ii) Recommendation: Restore windows by removing existing paint finish, replace damaged sections and re-finishing. Construct storm sashes to match existing for windows that do not have any. Reseal skylight and flashings with roofing replacement. There are 59 - 2' x 6' upper level windows, 1 - 2' x 4' upper level window, and 8 - 1.5' x 4' basement windows. Total of approximately 764sf of window area. The wood of the exterior windows will continue to weather without refinishing.
- iii) Estimated Cost: Replacement cost of windows would be around \$50,000. I would expect the refurbishment of the existing windows would be at least as much.

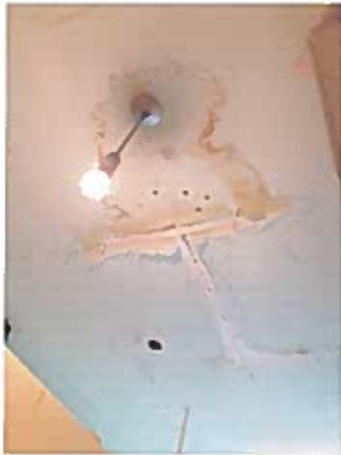
- i) Condition: There are several areas of damage from roof leaks throughout. The suspended ceiling also has water damage.
- ii) Recommendation: Repair ceiling plaster and re-paint following roofing replacement. In the barrier free washroom, remove the suspended acoustic tile ceiling, extend the walls full height for typical plaster ceiling finish.
- iii) Estimated Cost: \$1,000 to repair an area of approximately 250sf.

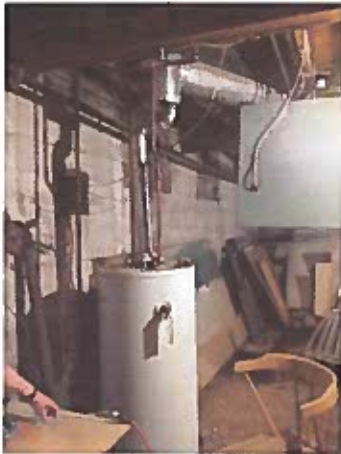
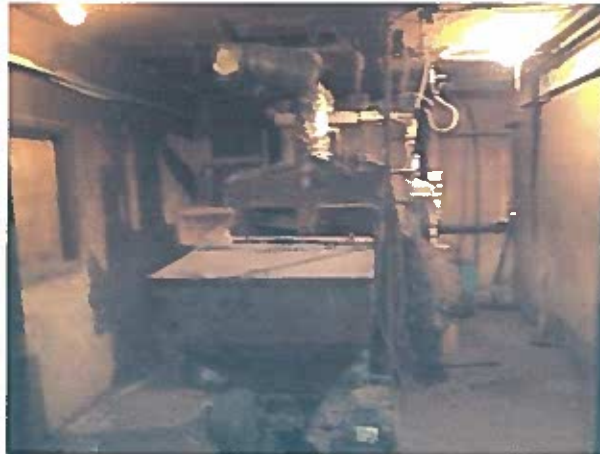
- i) Condition: The steam boiler is no longer working and replacement parts are unavailable. The newer gas fired space heater is being used to heat the entire facility but does not have any distribution infrastructure. The space heater is not suitable equipment or sized adequately for the facility and the flue location is causing roofing problems. It also can affect the relative humidity in the building which may have a detrimental effect on some building components. The newer equipment is not located in a mechanical room.

- ii) Recommendation: Provide a new high efficiency gas fired steam boiler to replace the existing. Flush the existing radiation cabinets and replace valves. Relocate the hot water tank into mechanical room. Exhaust the new boiler and hot water tank through the existing chimney with a new liner. Retain the existing boiler for historic reference.

- iii) Estimated Cost: \$50,000 including related accessories such as pumps and flue. (this is a difficult number to ascertain without a mechanical engineer's recommendation)
